SUBJECT: Asbestos Inspection Reports for F-22 Beddown Facility, Langley AFB, Virginia

LANGLEY AIR FORCE BASE BUILDING 754 HAMPTON, VA AMENDED SAMPLE LOCATIONS

ASBESTOS INSPECTION REPORT

FOR LANGLEY AIR FORCE BASE BUILDING 755 HAMPTON, VA 23665

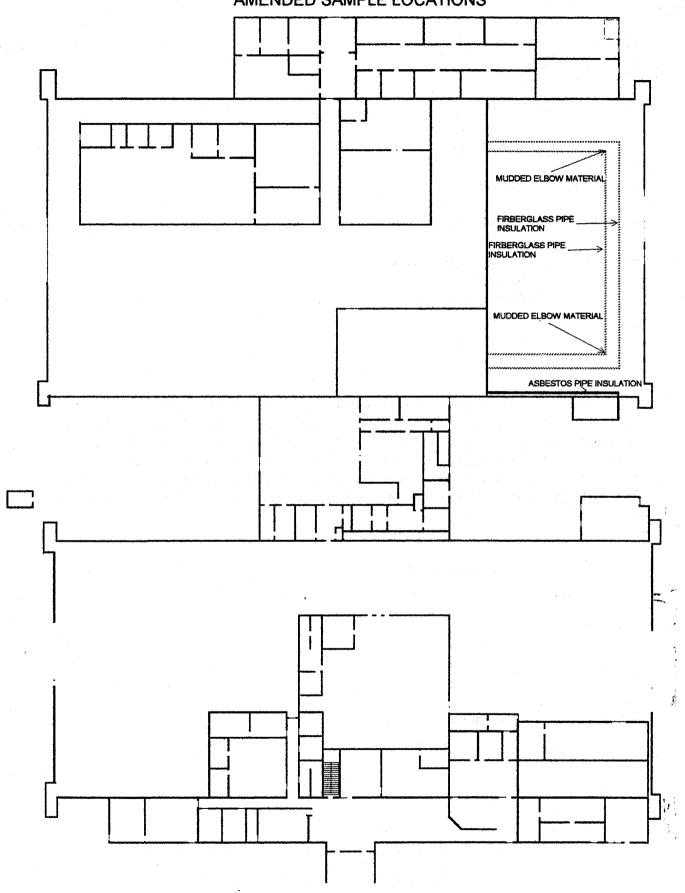
On July 24, 2001Marine Chemist Service has conducted an investigation of the pipe insulation located on the street side of the hanger building 754. Please be advised that two of the three pipes contain fiberglass insulation. One of the two fiberglass insulated pipes has two mudded elbows. This mudded material tested positive in similar materials during a previous survey. However, these mudded elbows were not included with quantities of asbestos material. The third pipe has insulation that tested positive for asbestos and quantities were included in the previous survey.
